DEPARTMENT OF TRANSPORTATION

Quality Assurance and Source Inspection

Contract #: 04-0120F4Cty: SF/ALA Rte: 80 PM: 13.2/13.9File #: 69.28**WELDING INSPECTION REPORT****Resident Engineer:**Pursell, Gary**Address:** 333 Burma Road**City:** Oakland, CA 94607**Report No:** WIR-012518**Date Inspected:** 11-Feb-2010**Project Name:** SAS Superstructure**OSM Arrival Time:** 645**Prime Contractor:** American Bridge/Fluor Enterprises, a JV**OSM Departure Time:** 1845**Contractor:** Zhenhua Port Machinery Company, Ltd (ZPMC), Changxing Island **Location:** Shanghai, China**CWI Name:** Du Zhi Qun, Li Lin.**CWI Present:** Yes No**Inspected CWI report:** Yes No N/A**Rod Oven in Use:** Yes No N/A**Electrode to specification:** Yes No N/A**Weld Procedures Followed:** Yes No N/A**Qualified Welders:** Yes No N/A**Verified Joint Fit-up:** Yes No N/A**Approved Drawings:** Yes No N/A**Approved WPS:** Yes No N/A**Delayed / Cancelled:** Yes No N/A**Bridge No:** 34-0006**Component:** Tower Components**Summary of Items Observed:**

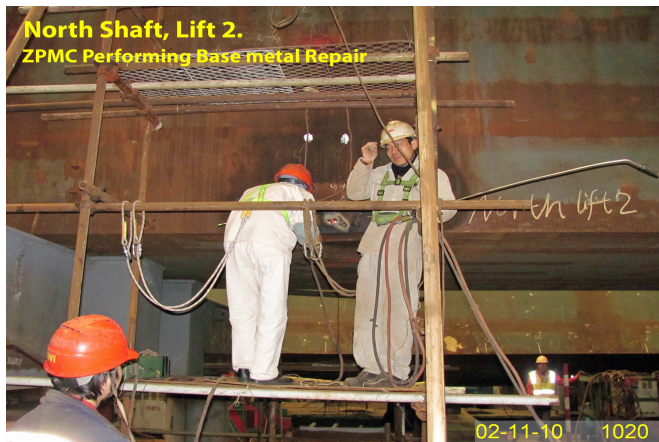
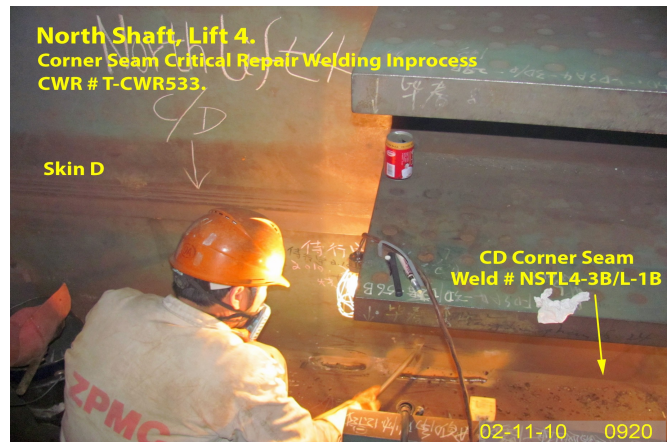
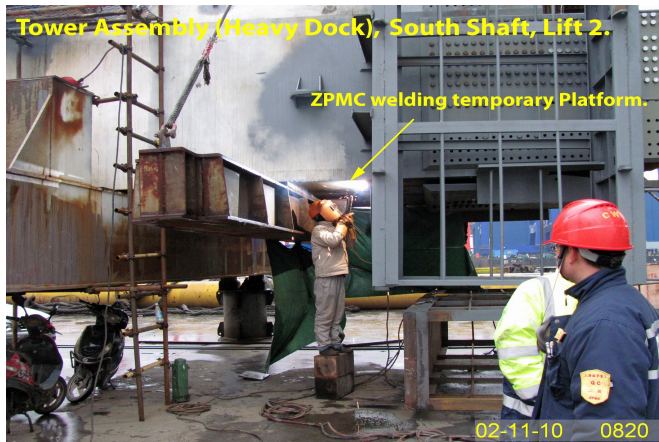
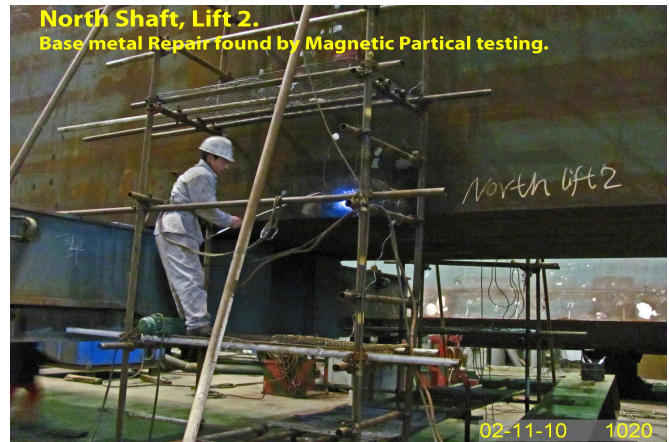
SMAW "Fifth time" Repair welding of weld joint NSTL4-3B/L-1B (CWR # T-CWR533); located on Bay 10, North Tower, lift 4. Welders are identified as 052930; ZPMC Quality Control Inspector (QC) is identified as Du Zhi Qun. The welding variables recorded by Quality Control Inspector (QC) appeared to comply with the Applicable WPS: WPS-345-SMAW-1G(1F)-REPAIR. The attached photographs provide additional detail.

Welding Temporary Platform for the tower in process. The attached photographs provide additional detail.

ZPMC Performing Basemetal Repairs on North Tower Lift 2. ZPMC have temporary Weld Repair Report (WRR) for these repairs. The Repairs found by Visual & Magnetic Particle Testing(VT & MT). The attached photographs provide additional detail.
